**DEPARTMENT OF TRANSPORTATION****DIVISION OF ENGINEERING SERVICES**

Contract #: 04-0120F4Cty: SF/ALA Rte: 80 PM: 13.2/13.9File #: 69.28**WELDING INSPECTION REPORT****Resident Engineer:**Pursell, Gary**Address:** 333 Burma Road**City:** Oakland, CA 94607**Report No:** WIR-008650**Date Inspected:** 18-Aug-2009**Project Name:** SAS Superstructure**OSM Arrival Time:** 700**Prime Contractor:** American Bridge/Fluor Enterprises, a JV**OSM Departure Time:** 1900**Contractor:** Zhenhua Port Machinery Company, Ltd (ZPMC), Changxing Island **Location:** Shanghai,China**CWI Name:** Lv Li Qing / Shen Fu You**CWI Present:** Yes No**Inspected CWI report:** Yes No N/A**Rod Oven in Use:** Yes No N/A**Electrode to specification:** Yes No N/A**Weld Procedures Followed:** Yes No N/A**Qualified Welders:** Yes No N/A**Verified Joint Fit-up:** Yes No N/A**Approved Drawings:** Yes No N/A**Approved WPS:** Yes No N/A**Delayed / Cancelled:** Yes No N/A**Bridge No:** 34-0006**Component:** OBG Assembly**Summary of Items Observed:**

OBG Bay No. 14

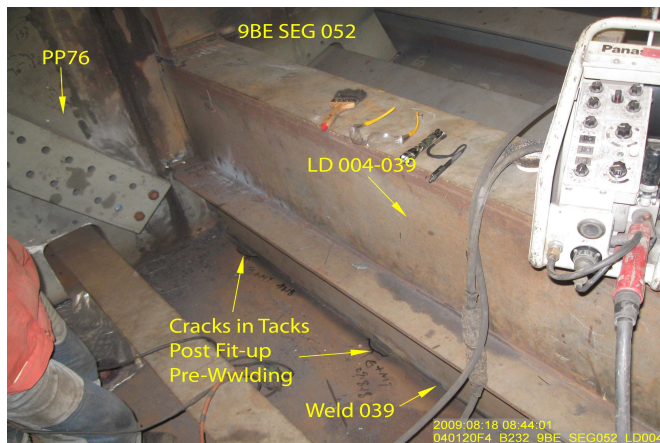
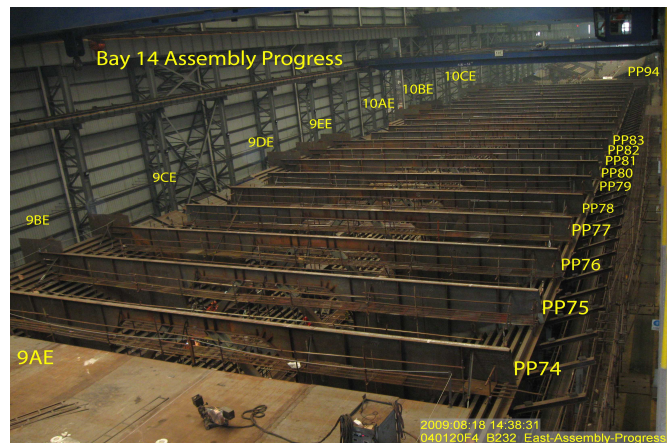
On assembly 9BE SEG 052C the QA inspector observed two (2) crack tacks on Longitudinal Diaphragm LD 004 - 039 weld number 039. The tack welds appear to have cracked after the fit-up process and prior to welding the fillet weld. See photographs for additional information.

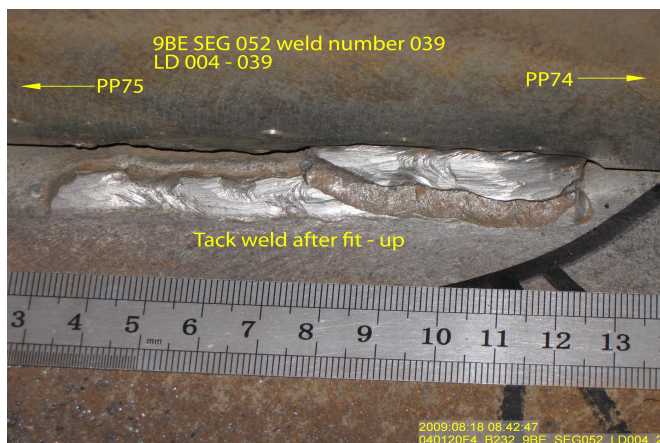
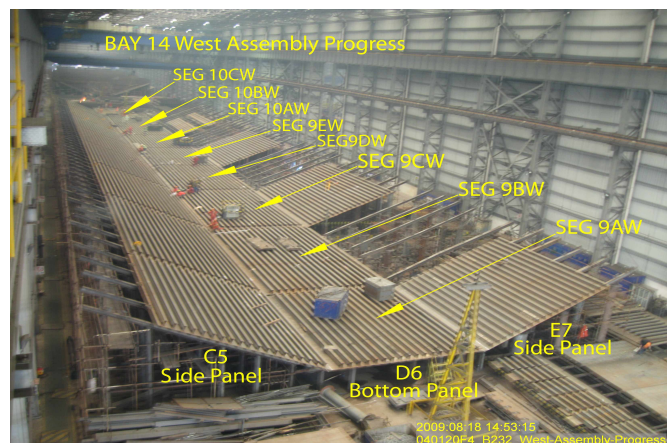
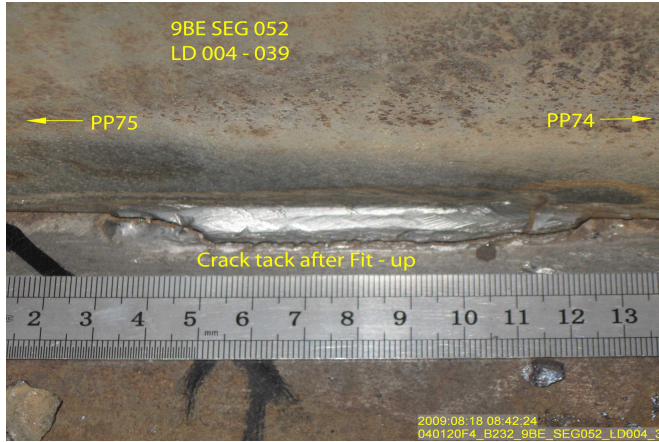
Currently all Floor Beam components are installed in East fixture of bay 14 and majority of side panels and bottom panels are installed in west fixture of bay 14. See the photographs for more information on the components located in east and west assemblies.
